ANALYSIS OF THE PATOS DAM IN THE MUNICIPALITY OF SOBRAL IN THE STATE OF CEARÁ IN THE NORTHEAST SEMIARID

PATOS DAM ANALYSIS

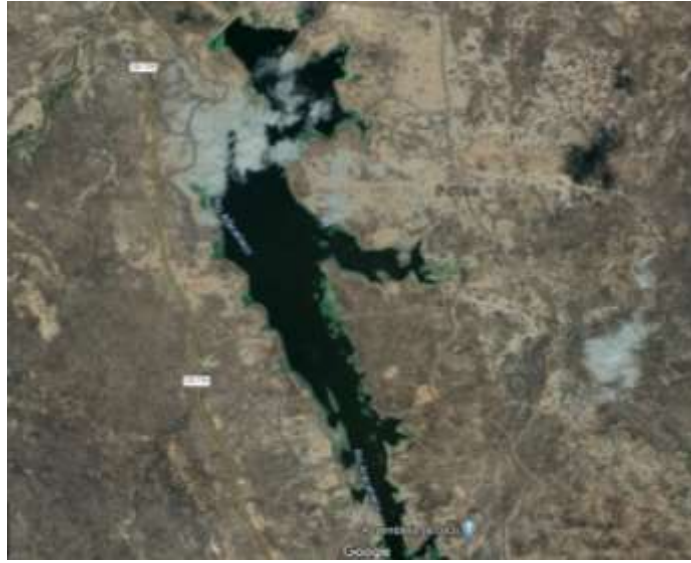
Figure 2 – Patos Dam Reservoir.

As it was possible to see in Figure 2, the reservoir of the Açude Patos has a length much greater than its width. This great length of the reservoir is encompassing the entire bed of the Aracatiaçu River close to the dam and its tributaries that are close to the reservoir.

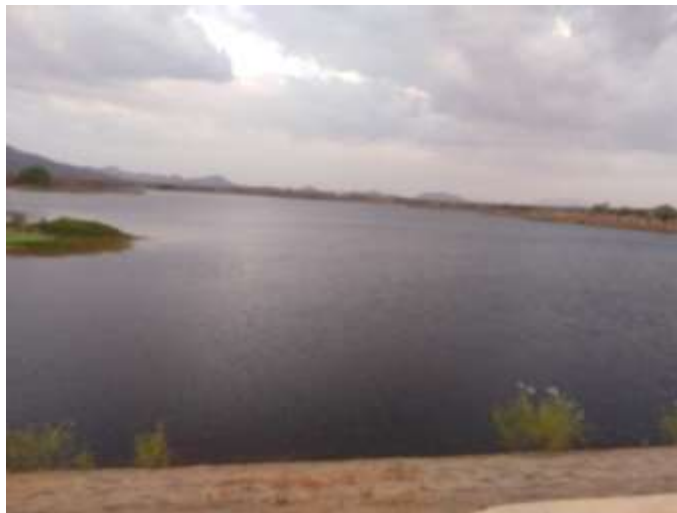
Figure 3 – Reservoir of the dam with a good amount of water.

It was possible to see the reservoir of Açude Patos from above the dam, with a satisfactory stored water capacity after a winter with a good amount of rain in the northern region of the State of Ceará in 2019 (Figure 3).

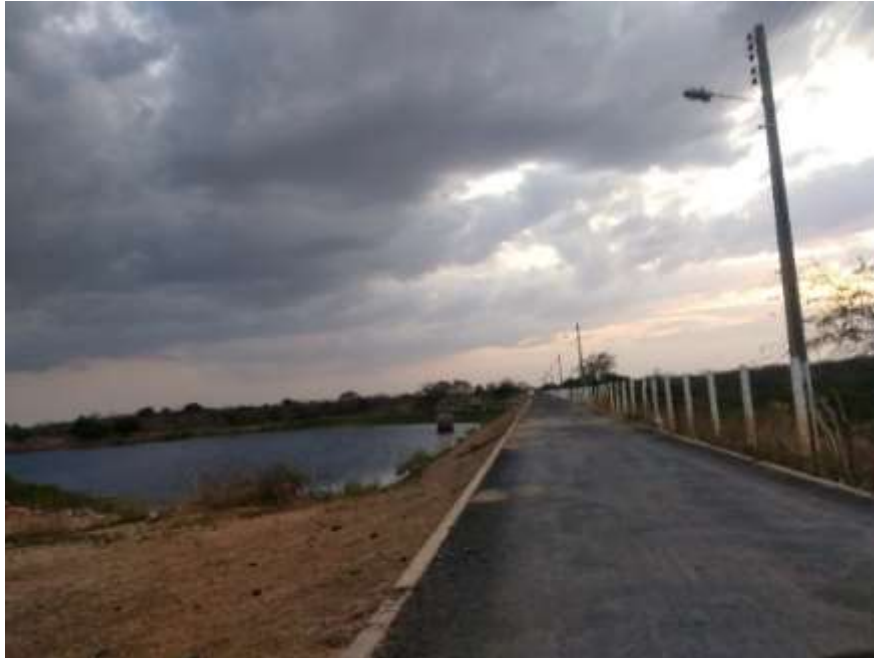
Figure 4 – Patos dam where there is a carriageway on its crest.

Figure 4 shows the dam of the dam where on its crest there is an asphalted roadway that gives access to the state road CE-176 that connects the locality of Patos (district) to the district of Santo Antônio do Aracatiçu that bears the name of the river, which is dammed by the Patos dam, which is the Aracatiçu River. It was also possible to detect the water intake and the fence made of concrete pillars with barbed wire, on the left bank of the

crest of the dam with lampposts. The fence serves to demonstrate that the right side of the weir dam has become private property.

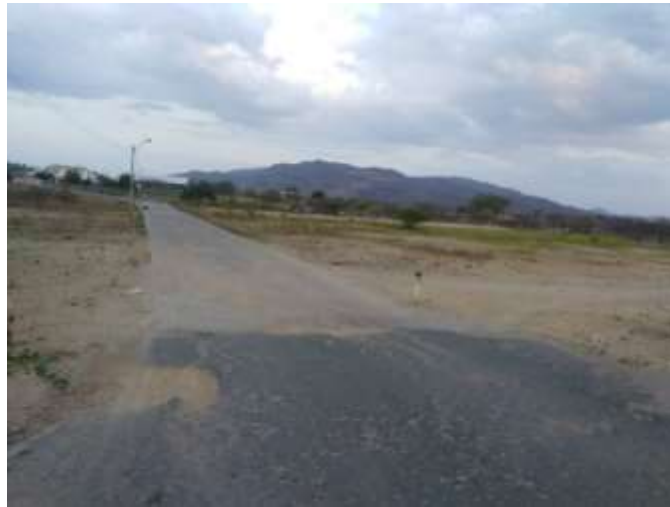
Figure 5 – Bleeding and the raceway over the bleed.

The Patos dam has two spillways, where in one of the spillways there is a passage over one of the spillways made of concrete that connects the District of Patos to the dam where there is a carriage way, and it is possible to see the end of the surface in concrete (bleeder) and the beginning of the rolling surface with asphalt that will pass over the crest of the dam. During the winter with the incidence of rain, depending on this incidence, the water submerges the passage made of concrete and it is impossible for traffic to pass through the site. Figure 5 shows one of the spillways and the carriageway made of concrete over the spillway with more than 100m in length and at the end of the spillway on both sides, the continuation of the road made of flexible pavement (asphalted road) begins. It was also possible to see that buildings in the district of Patos in the municipality of Sobral were built close to the shore of the Patos dam that leads to the same in the district, such as the sports gym in the locality of Patos and emphasizing that the reservoir of the dam is close to Serra Manuel Dias. The peculiarity of having two spillways occurred due to the dimensioning of the hydraulic basin of the Aracatiaçu River in the dry (semi-arid) region of the north of the State of Ceará in Brazil.

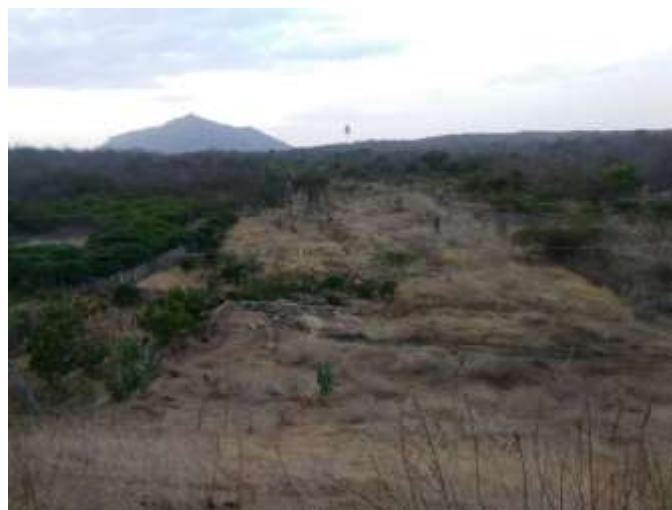
Figure 6 – Dry bed of the Aracatiaçu River downstream of the dam.

The Patos dam has two spillways, where in one of the spillways there is a passage over one of the spillways made of concrete that connects the District of Patos to the dam where there is a carriage way and it is possible to see the end of the surface in concrete (bleeder) and the beginning of the rolling surface with asphalt that will pass over the crest of the dam. The dry riverbed of the Aracatiaçu River downstream of the dam can be seen in Figure 6, where it is also possible to see the barbed wire fences that delimit the riverbed of the Aracatiaçu River. Today, where the Aracatiaçu River passed before the construction of the Patos Dam, there is very little vegetation. The fences made with wooden stakes (trees present in the caatinga) and barbed wire, which were placed on the banks of the Arataiaçu River, are totally irregular because after the dam was built in 1921, the landowners on the banks of the Arataiaçu River took the entire area of its riparian forest in a totally irregular way.

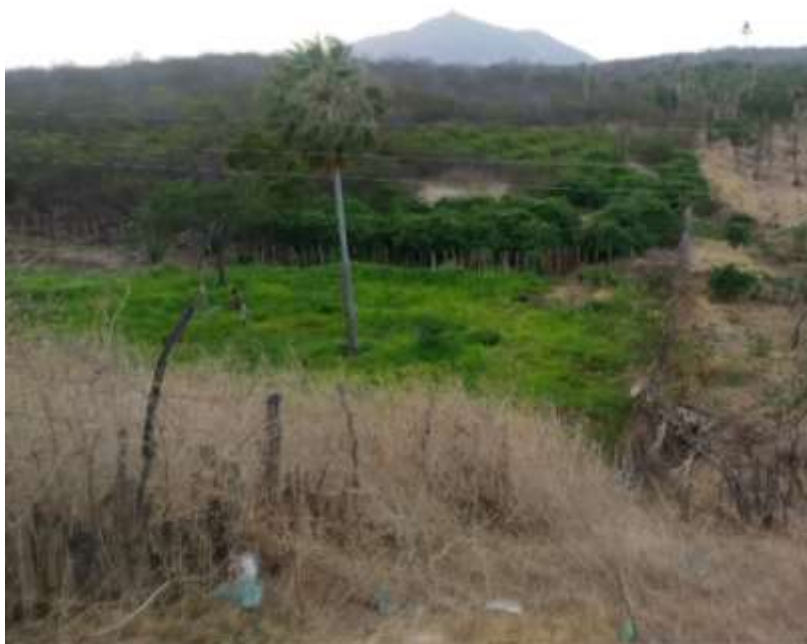
Figure 7 – Planting some crops downstream of the dam.

On the left side of the riverbed of the Aracatiaçu River, where we see the dry part, we have some crops planted where we can see in Figure 7 a greener area to the left of the fence that was built of wood (thrush, jurema) which is a vegetation typical of the dam biome. caatinga present in the semi-arid region of the State of Ceará, which delimits the bed of the Aracatiaçu River where it was possible to see a man watering the plantation with water coming from the Patos Dam itself. Part of the green area belongs to the riparian forest of the Aracatiaçu River.

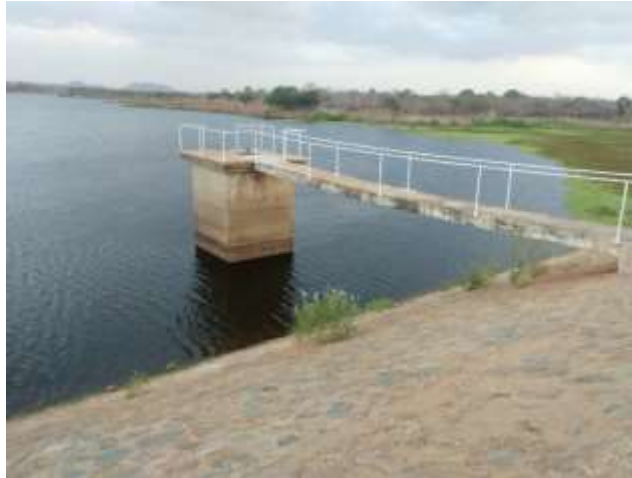
Figure 8 – Stone-lined earth dam and reinforced concrete water intake.

Most dams built in the semi-arid region of northeastern Brazil are built (made) from earth dams, where only the Castanhão dam located in the municipality of Jaguaribara, which dams the Jaguaribe River, has a dam built of earth and CCR concrete (CCR). roller compacted). Figure 8 shows the dam at Açude Patos, which was made of earth covered with stone and the water intake was made of reinforced concrete, where it is possible to see the bridge (walkway) with a guardrail, between the dam and the water intake, to be able to access and be able to activate the water intake valve.

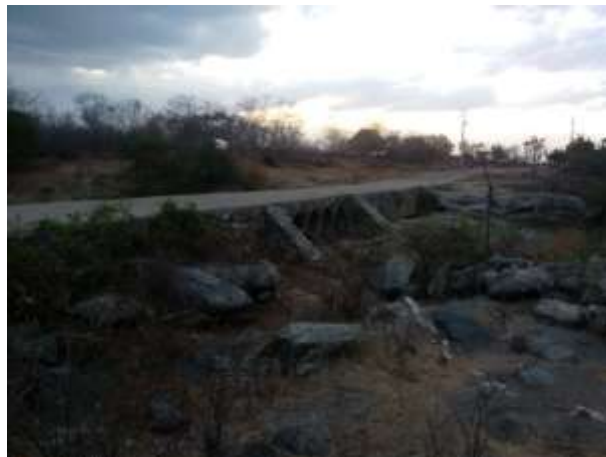
Figure 9 – Bleeding on the side of the left abutment of the dam.

The other spillway is on the side of the left abutment of the dam and was built of stone and concrete, which also works as a wet passage where it was possible to notice the existence of four concrete pipes that were placed for the passage of water when the dam is bleeding. The structure of the spillway (spillway) has erosion points (pathological manifestation) that occurred due to the passage of water through the spillway over the years (100 years) of the structure's existence (Figure 9).

The Patos dam needs maintenance by the DNOCS (National Department of Works Against Drought) which is the Federal Government agency responsible for the engineering work as it presents some pathological manifestations such as erosion, the spillway, and the transverse undulation of a plastic nature in the asphalt coating on the surface of the crest of the Patos dam.

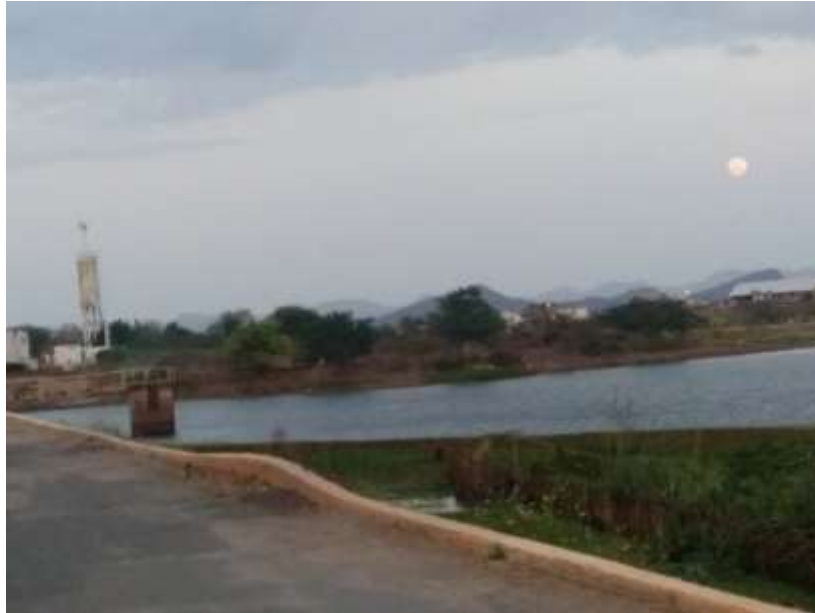
Figure 10 – Rippled flexible pavement, moving the dam crest curb on the dam's upstream side.

In the Patos dam in the municipality of Sobral, it was possible that the road with flexible pavement passes over the crest of the dam and that the flexible pavement presents pathological manifestations, such as transverse undulation (pathological manifestation) of a plastic nature in the asphalt coating. This ripple is related to the passage of vehicles over the crest when accelerating or braking vehicles. The undulation (sag) of the pavement displacing the curb of the crest of the dam found on the upstream side of the

dam can cause accidents for people traveling over the crest of the dam of the Patos dam (Figure 10).
